**FIELD ACTIVITIES REPORT
Mine Adit Entry**

**RED AND BONITA MINE SITE
Silverton, San Juan County, Colorado**

TDD No. 1008-01

January 20, 2012

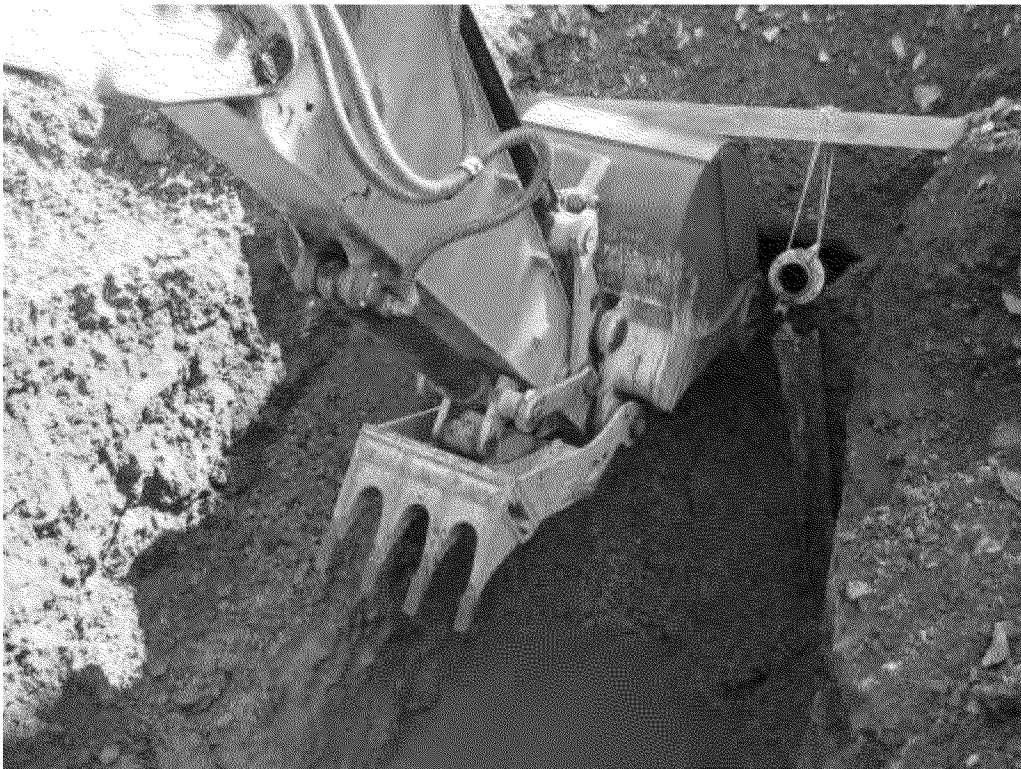
PHOTO 38 9-29-2011

Removing upper portion of remaining collapse material to allow AMD water to flow out of adit.

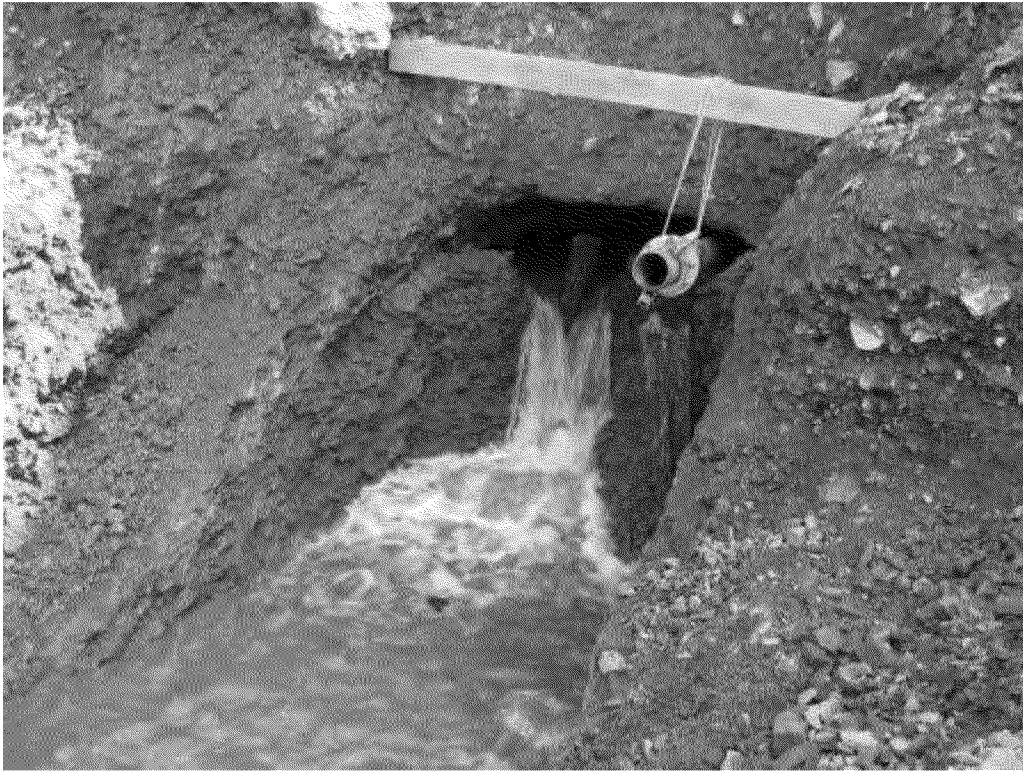
A ferricrete brow forming the top of the adit portal was readily distinguished and outward sloping ferricrete formed the sides of the adit in wedge shapes, apparently formed as the adit was cut into the sloping ferricrete formation (Photo 39). The ferricrete formation at the adit entrance appears to have formed at a slope angle similar to the existing mountainside slope. An approximate 2-foot thickness of material, mostly fines apparently transported by out-flowing AMD, was observed on

PHOTO 39 9-29-2011
AMD water flowing from adit.

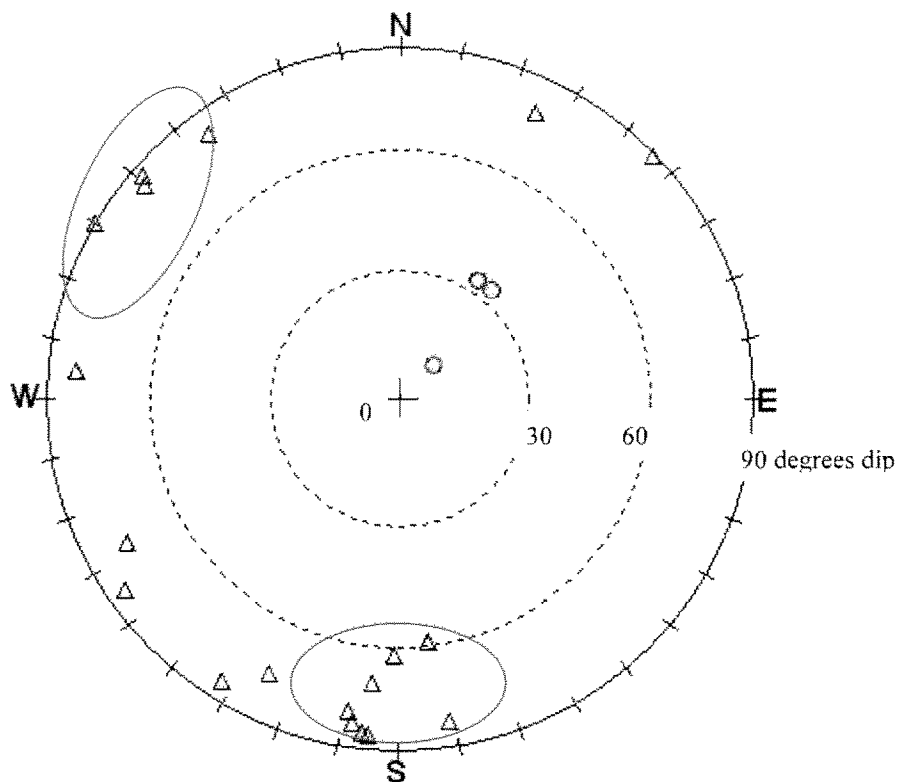
Figure 3. Pole plot of surface planar discontinuities measured around the Red & Bonita Workings. Triangles indicate poles of minor joints; circles indicate poles of flow laminations in andesite rock. The plot shows a cluster of poles to the south and a weaker set in the northwest sector, indicating two trends of anisotropy in the surface bedrock.

The southern pole cluster represents a set of joints trending roughly east-west, with dips of 60 to 89 degrees to the north. The northwest pole cluster represents joints striking roughly northeast-southwest, dipping steeply southeast. These orientations are similar to the dominant northeast-southwest anisotropy noted in the Simon Hydrosearch report prepared for the Sunnyside Mine (Stock, et. al, 1992,1993). They reported permeability greater in a northeast-southwest direction due to the dominant fracture orientation within this section of the Eureka Graben. The structural discontinuities measured in this study tend to agree with the direction of structural anisotropy as shown on published geologic maps and reports for this area near the Eureka Graben. Flow structure (crude bedding) in the andesite strikes south-east and dips gently southwest.

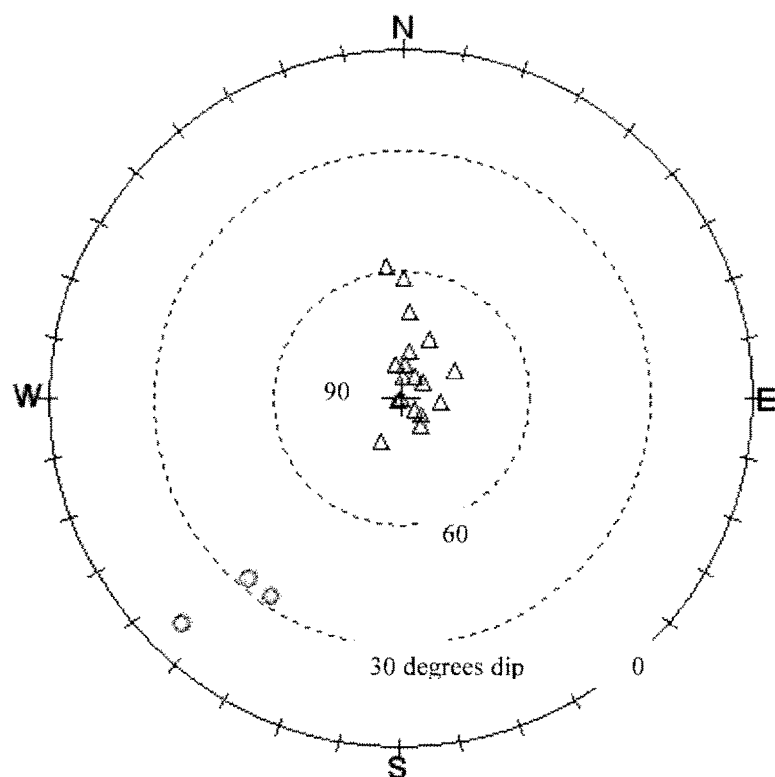
Figure 4. Dip vector plot for planar discontinuities measured on surface around the Red & Bonita workings. Triangles indicate dip of minor joints; circles indicate dips of flow laminations in andesite rock. Most joints are steeply dipping, while flow structure has shallow dips.
